# UH-1 ACCIDENT SUMMARY

Majors, Minors,  
Incidents,  
Forced Landings,  
Precautionary Landings

1 JULY 1960 THROUGH  
30 JUNE 1965

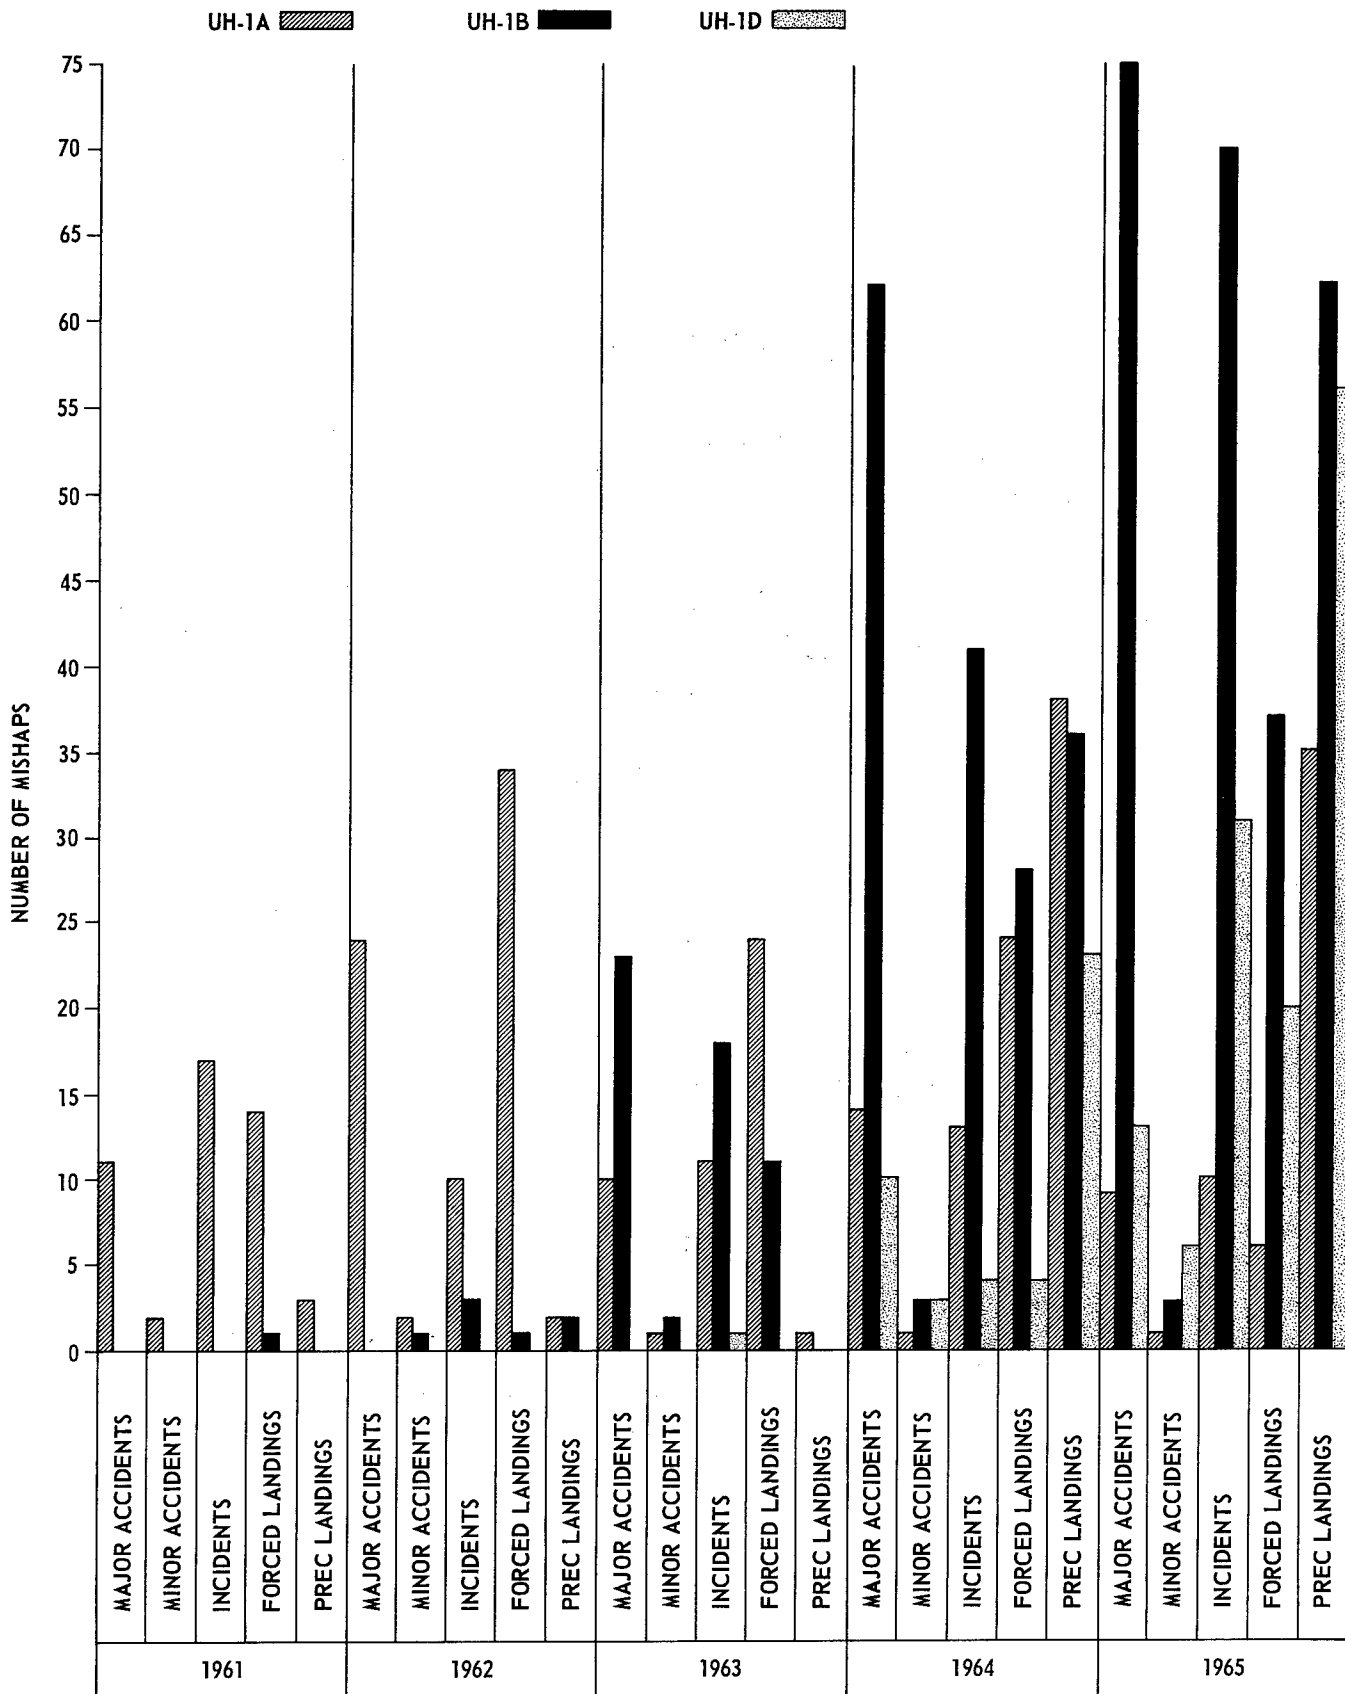
FIGURE 1  
TOTAL MISHAPS BY NUMBER AND TYPE  
FY 1961-1965

a. Of the 967 mishaps which happened during the five year period shown in figure 1, 840 (approximately 87%) happened during the three year period FY 1963-FY 1965. UH-1B and UH-1D model aircraft were added to the inventory and increased flying requirements, including expanded training, were added to meet the demand of the Vietnam conflict.

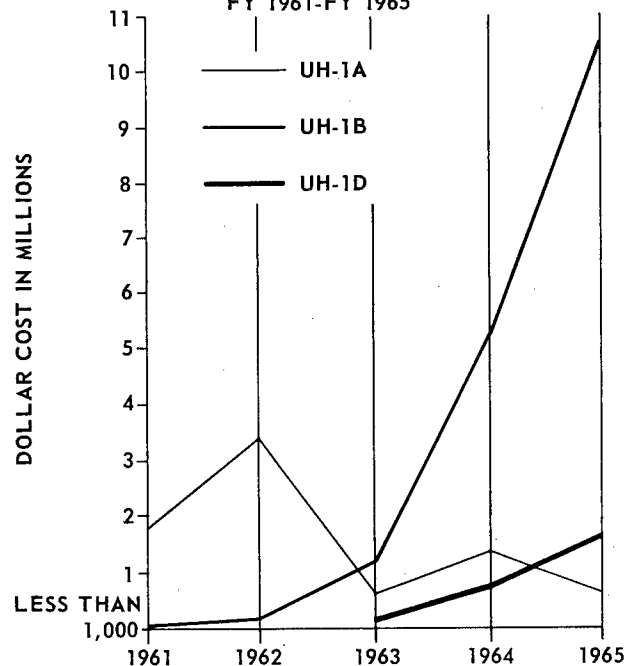
**FIGURE 2**  
**DOLLAR COST OF ALL ACCIDENTS AND INCIDENTS**  
**FY 1961-FY 1965**

b. Figure 2 shows the dollar cost of UH-1 mishaps. The cost of repairing aircraft damaged by accident is directly proportionate to the severity of the accident and the original cost. As equipment becomes more complex, mishap costs rise. This is evidenced by the cost of UH-1B mishaps which rose to more than \$10,000,000 during FY 1965. The cost for all Army aviation mishaps during FY 1965 exceeded \$26,000,000.
